Thank you for your time discussing the irrigation pump station at Hughes Creek. This assessment of the pump station will help clarify and explain the issues found with the pump station, which is clearly in urgent need of replacement.

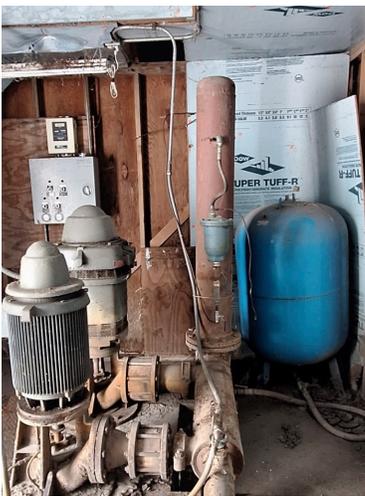
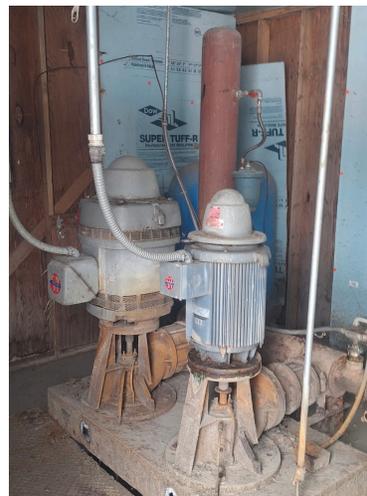
Visually, the skid and piping are extremely rusted and corroded. What you can see on the outside is indicative of what the inside looks like too. Most piping that looks like this has already started developing pinhole leaks or has structural issues. We use a product called fusion bonded epoxy; it's applied like a powder coat to the inside and outside of the entire station and piping to keep the station looking like new for a long time.

The most critical issue is the vertical piece of pipe on the discharge header. This is acting like an air over water pressure tank or surge tank. This piece of pipe has the same potential to blow up as a larger pressure tank. When these fail, it is violent and life-threatening to anyone in the pump house. This is not just a pump station issue, but a legitimate safety concern and business liability.

Most of the damage to the skid and outside of the piping is from the leaking packing at the pump shaft. This is likely the result of maintenance neglect to the existing system. This damage alone makes the existing system beyond reclamation. Nuco uses mechanical seals that keep all water inside the pump and do not require daily maintenance. This will keep your new pump from ever facing a similar issue.

Our strong recommendation is to replace this station as soon as possible.

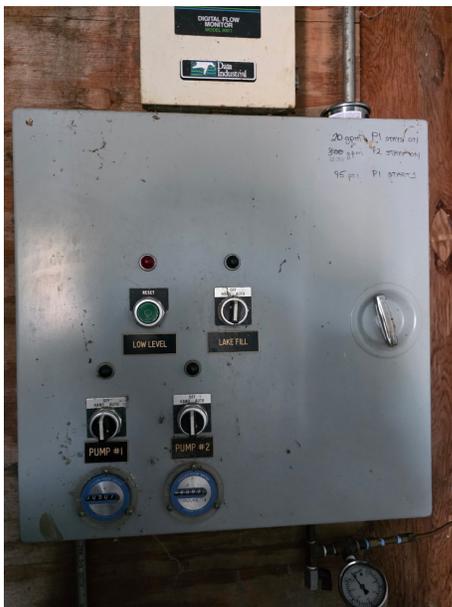
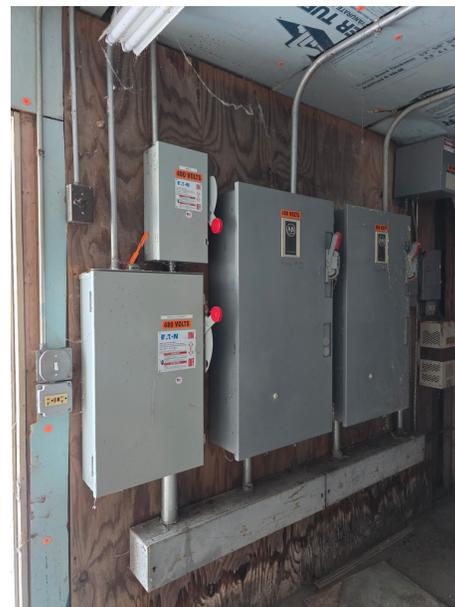
Additionally, the existing station does not have any way to control or relieve the pressure going to the system. The controls are very basic and can only turn a pump on or off at full speed. This stresses the entire

irrigation system and pump station, especially one of this age. There isn't a pressure relief valve, which is standard equipment on our new pump station. This feature would allow for any overpressure that might arise from situations like valves opening or closing too quickly to be gradually dissipated. This not only protects the pump station, but also significantly reduces the likelihood of irrigation head blowouts and other damage throughout your entire irrigation system network caused by surging.

Further, the flow meter on the existing system is not in the correct location and cannot possible function accurately the way it is installed. Inaccurate flow measurement impacts the timing of the pumps turning on and off, which in turn makes it impossible for the system to run efficiently.

Additionally, there is no pressure maintenance pump in the existing system. This is a small pump used to maintain constant pressure at a set point between irrigation cycles and to keep a main pump from cycling on during non-irrigation times.

Finally, virtually all parts and components from the existing system are obsolete and unavailable.

A new station solves all of these issues for a long time (conservative useful life is 15-20 years). With a new station, Nuco includes remote access which provides monitoring and notifications of all system alarms and faults to our service and factory personnel. This is the equivalent of Hughes Creek having a person on staff monitoring the station. Our field service personnel, factory technicians, and key staff members at Hughes Creek receive the same notifications at the same time.
